# Manhole Inspection Summary

Manhole # S33Y\_\_007MH

Insp Date: **7/28/09 9:32 AM**

**Location** Address: **200 W McCOMAS ST**

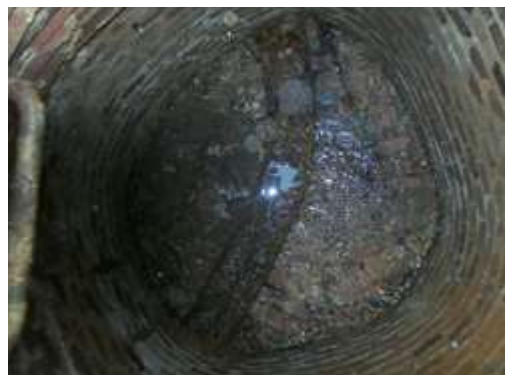
Top View

POST DEBRIS REMOVAL

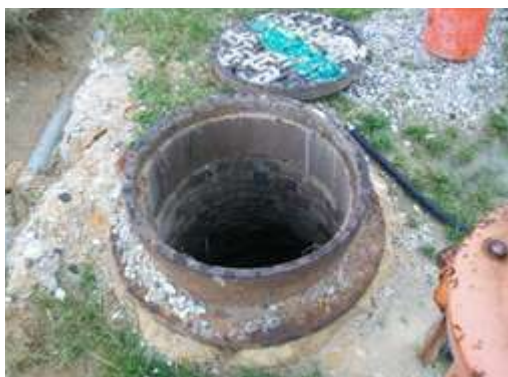
Miscellaneous

Frame View (open trench near mh)

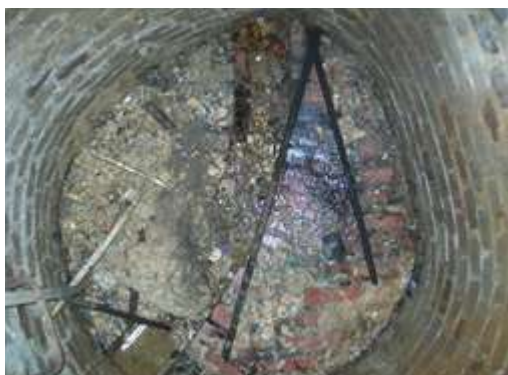
Defect 2

Condition: ☐ Sound ☐ Cracked ☐ Root Intrusion ☐ Deteriorated ☐ Leaks ☒ **Debris**

channel & bench debris (picture is before cleaning)

Comments **GROUND DOES NOT APPEAR TO BE GRADED PROPERLY; FORCED OPEN WITH 16LB MAUL; REMOVED HARDENED DEBRIS FROM CHANNEL BY HAND**

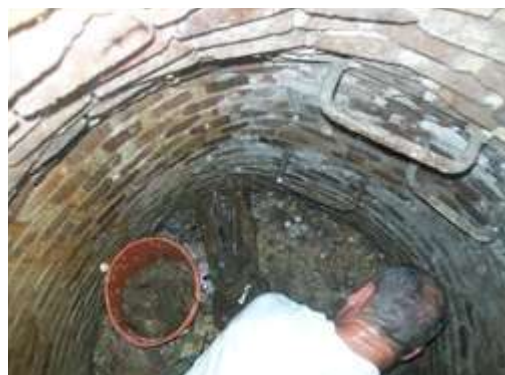
Defect 1

**Steps** Count: **4** Missing: **0** ☒ **Corroded**

corroded steps

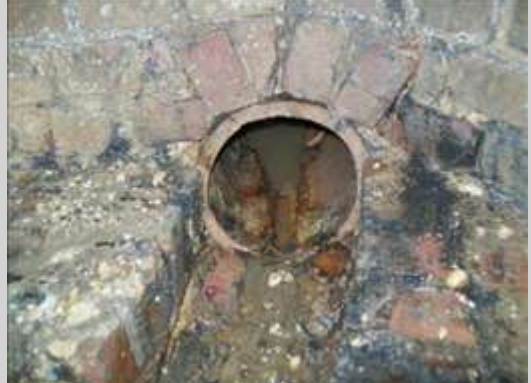
12 O'Clock Outflow

8 in. Circular Gravity Sewer  
Pipe Out @ 12 O'Clock

Pipe Height: **8.4** (in.) Rod and Bar (Angled)  
Pipe Material: **Clay** ☐ Pipe Lined  
Invert Depth: **8.40** (ft.) Flow Characteristics: **Slow**  
Deposits: ☒ None ☐ Mud ☐ Sludge ☐ **Debris** ☐ Grease  
Silt Depth: **0** (in.) Deposits Extent: **Medium**  
Infiltration: **None** Pipe Seal Cond: **Sound**

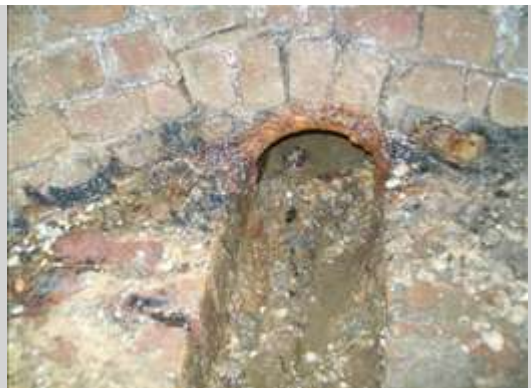
7 O'Clock Inflow

8 in. Circular Gravity Sewer  
Pipe In @ 7 O'Clock

Pipe Height: **8.4** (in.) Rod and Bar (Angled)  
Pipe Material: **Clay** ☐ Pipe Lined  
Invert Depth: **8.20** (ft.) Flow Characteristics: **Slow**  
Deposits: ☐ None ☐ Mud ☐ Sludge ☒ **Debris** ☐ Grease  
Silt Depth: **0** (in.) Deposits Extent:  
Infiltration: **None** Pipe Seal Cond: **Sound**
